CUSTOMER NAME:		E-MAIL:											
DAY TIME TEL No:		EVENING TEL No:											
CUSTOMER REPORTED ISSUE / REQUEST		<i>Detailed Report.</i>											
ADDRESS:													
Frame Serial No:													
DATE DUE:			£										
PRELIMINARY INSPECTION	RECOMMENDED WORK TO BE CARRIED OUT	PARTS	Labour	TOTAL									
<b>Service Type</b>	<b>Detailed Report</b>		<b>£ 25.00</b>										
Headset	Both bearings in good condition. No roughness or play noted.												
Bottom Bracket	Both bearings in good condition. No roughness or play noted.												
Front Hub	No roughness or play noted.												
Rear Hub	No roughness or play noted.												
Front Gears	Outer cable worn through by cable cross over near headset. <b>Cable should be replaced.</b>												
Rear Gears	Jockey wheels worn. Cable worn by hanger. * See Note below. <b>Cable replaced.</b> <b>Shimano XT Jockey wheels.</b>	<b>£ 5.00</b> <b>£ 16.90</b>											
Chain	Over 1% wear need to replace. <b>Replaced SRAM 951</b>	<b>£ 14.99</b>											
Chain Rings	Some wear visible on middle ring and large ring. Recommend replacing all 3 rings. <b>Middleburn 22T &amp; 32T Slick Shift.</b> <b>Shimano LX 44T .</b>	<b>£15.99</b> <b>£

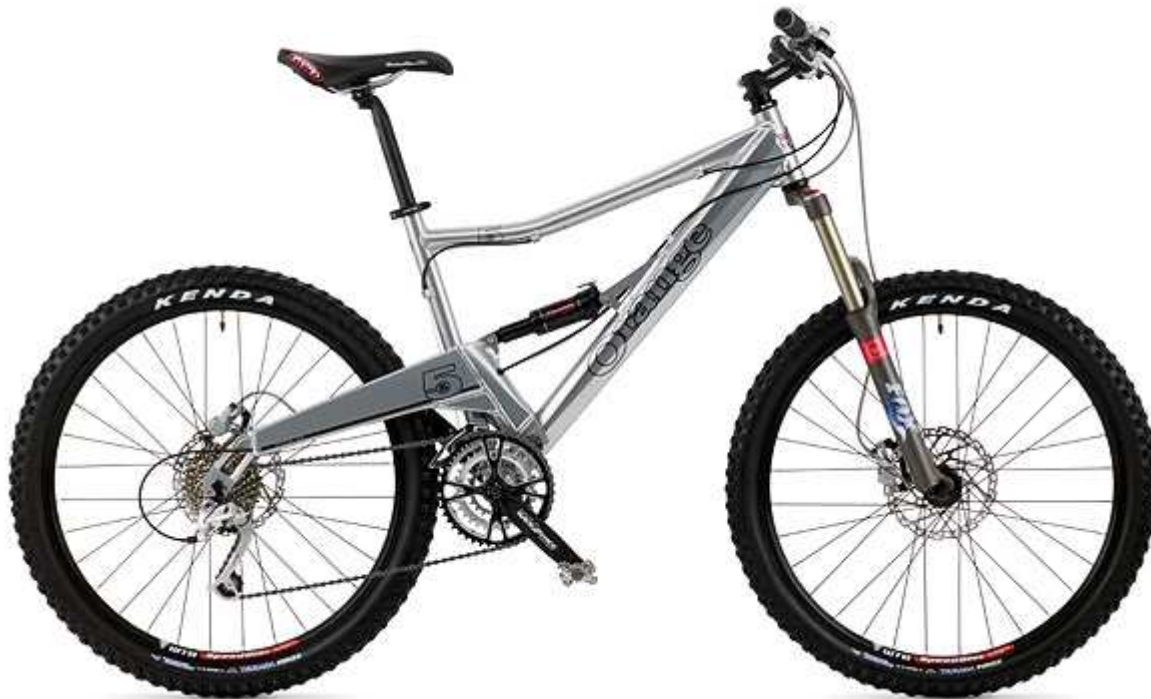
## Dents and Major Scratches

Normal scuff marks for bike of this age.
